Inspection Report Minerals Regulatory Program June 21, 2010

| Mine Name: Essex Mill Site Tailings Pond Reclamation | Permit Number: S/001/0075 |
| Operator Name: Gene Henrie – dba Quality Crushing | Inspection Date: 06/21/2010 |

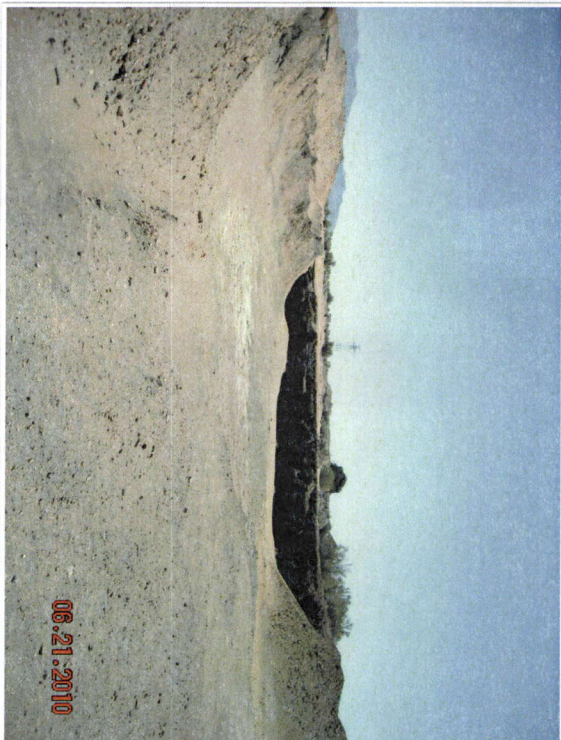
Very fine material with no apparent plant growth.

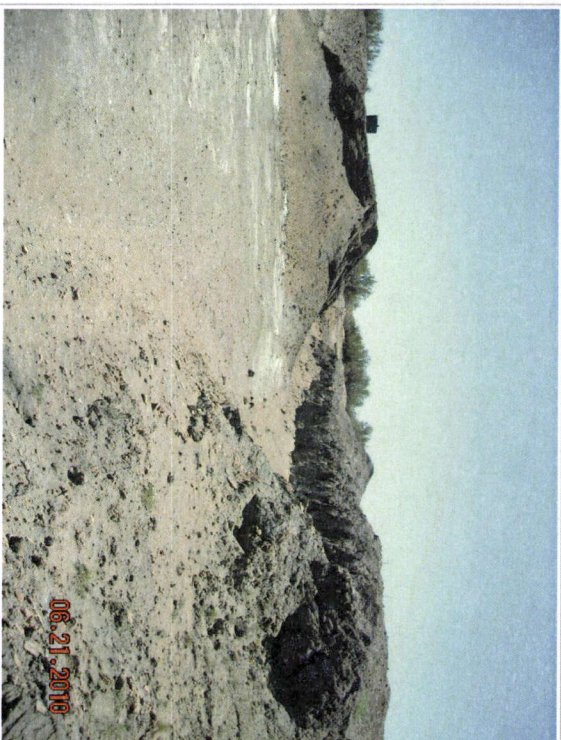
Ledges can be knocked-down and regraded!

- 1) The permit has been suspended for failure to pay annual permit fees. The operator should submit payment for 2009 along with this year's fee to bring the permit out of suspension.
- 7) All mud pits, ledges, and highwalls will need to be backfilled and/or regraded to match the existing topography once the operator chooses to reclaim the site.
- 9) The soil is organically poor and most likely incapable of supporting plant life. The soil is partially consolidated and contains abundant amounts of fines.
- 10) Poor vegetation conditions predate the current mining disturbance and revegetation is most likely unnecessary. Russian thistle is the only plant growing in the disturbance.
- 12) Photographs and a GPS map are attached documenting the conditions of the site.

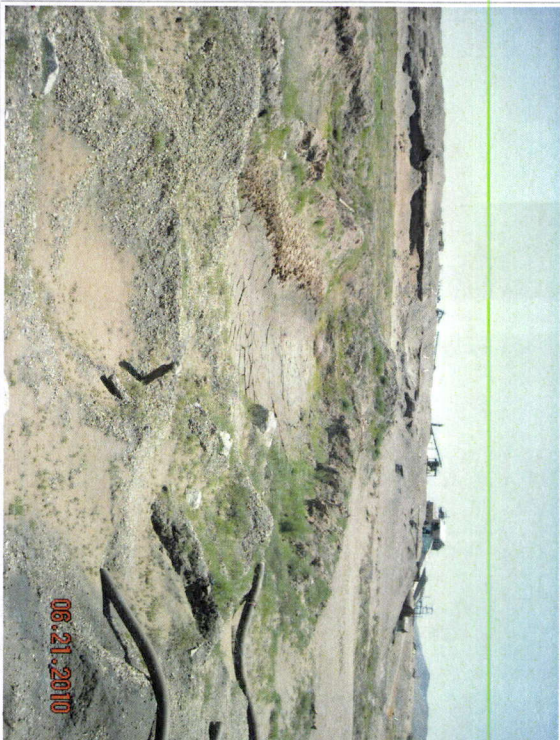
Mud pits with partially buried hoses and Russian thistle.

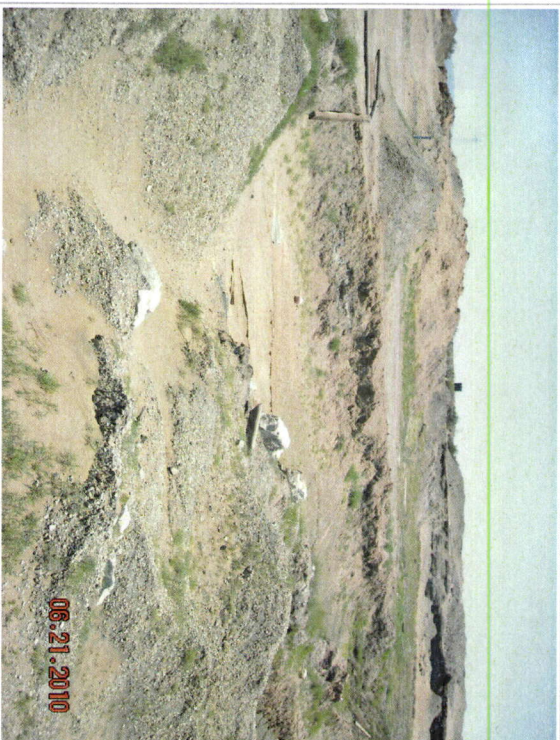
Collection of fines and Russian thistle.

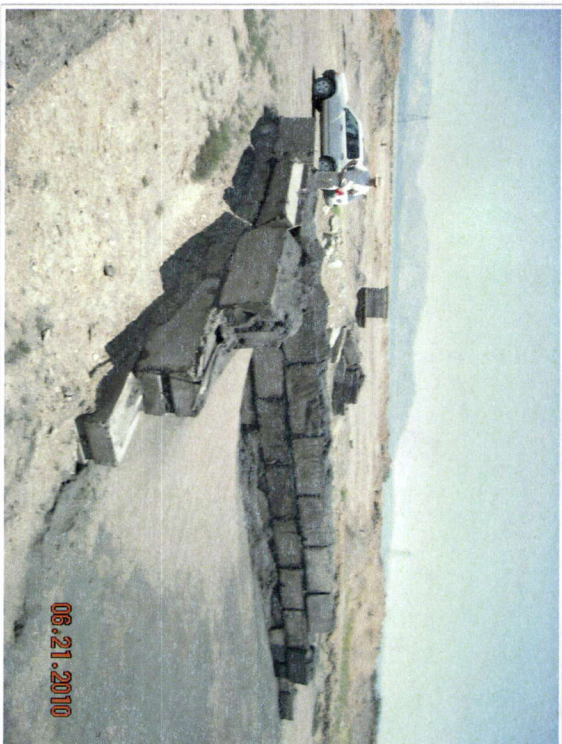
Load-out facility with wind blown fines.

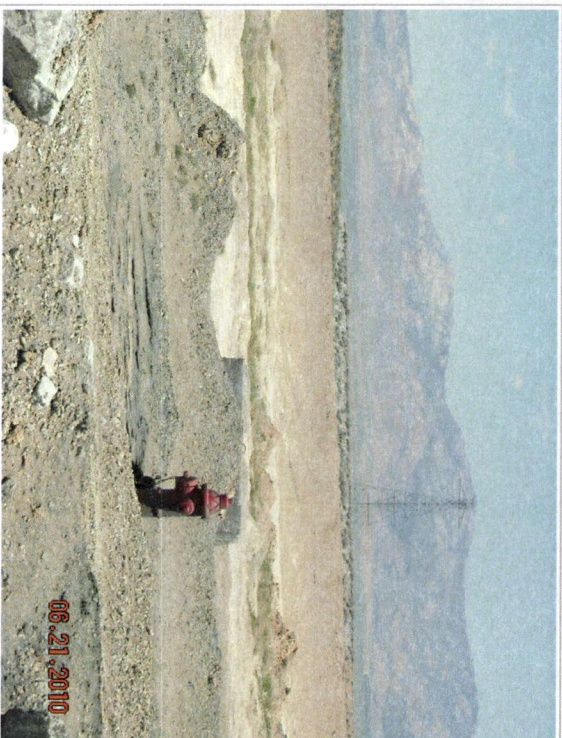
Water hydrant installed for mining activities.

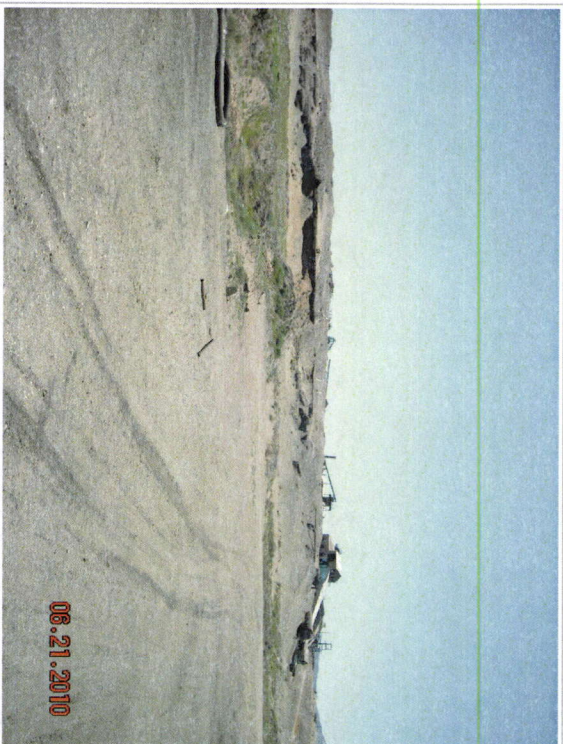
Dilapidated structures on the precipice of the hill predate current mining.

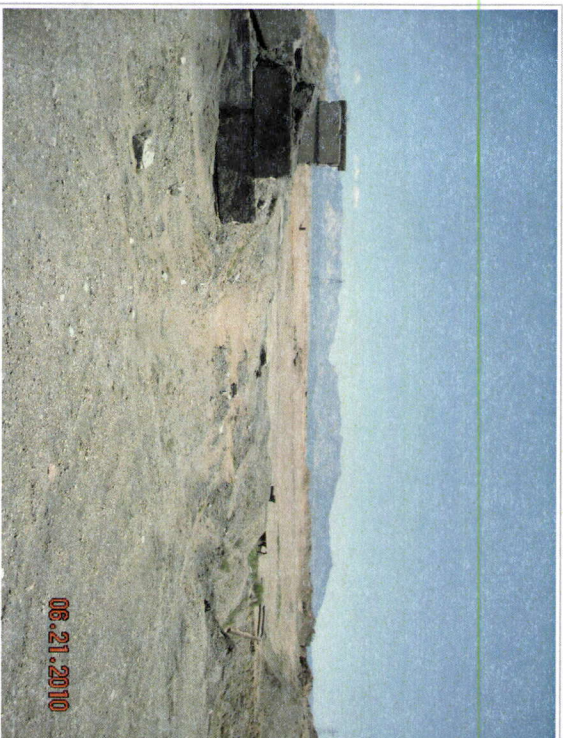
A whole lot of nothing!
